CONSERVATION ASSESSMENT REPORT

**PLUMB'S CHAMBERS
82 & 84 FITZROY ST
WARWICK**

**For
The McConaghy Group**

**Prepared by Watson Architects
July 2008**

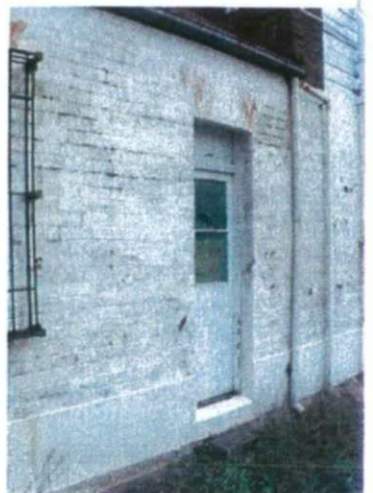
Figure 11

The rear unpainted masonry walls are in a similar condition. The eastern painted masonry wall also appears to have rising damp which has affected and degraded the painted surface. Refer Figure 11.

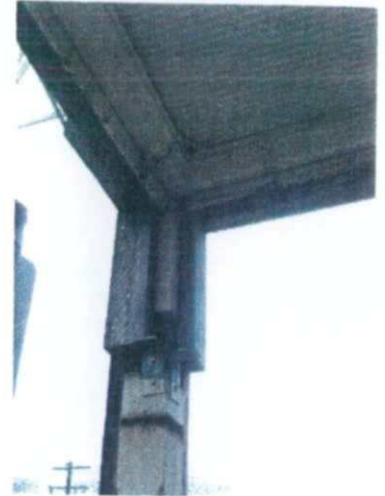
Figure 14

The timber verandah appears in poor condition with structural failure of the eastern-most corner timber post. Timber supports have been fixed to the post at the upper floor junction. Refer Figure 14. The upper floor structure appears to have moved away from the bearers and a significant fall on the verandah floor was noted. Verandah floor boards to this edge have degraded significantly. Refer Figure 15. The ripple iron soffit appears bowed and rusting in places. The internal perimeter gutter appeared sound. Sections of the timber slatted valence are missing.

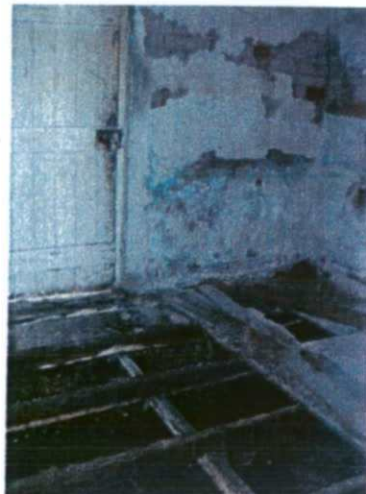
Figure 17

The ground floor exhibits extensive damage to the floor framing and the floorboards. Refer Figure 17. The ground clearance to bearers appears to be non-existent in some areas. The framing has both suffered from termite damage and rot. The majority of the floor appears unstable and unsafe. The floor boards have been fully removed from the south-western room of the building, exposing the floor framing and its proximity to the ground level. Refer Figure 18.

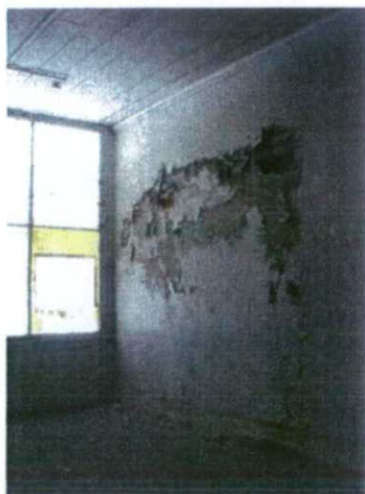
Figure 22

Termite damage was evident in the flooring, timber walls, timber trims and skirtings of the shopfront room inspected. The timber ceiling appeared relatively sound. Refer Figure 22.

Generally the rear section of the building appears substantially damaged due to water ingress, rising damp, termite attack and possible settlement within the walls. Refer Figures 21 & 22. The front section of the building exhibits significant termite damage, rising damp to the masonry walls and a rotted, failed floor structure. Refer Figure 23 & 24.

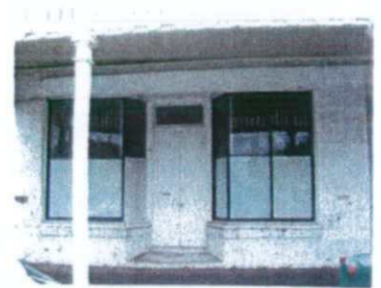
Figure 35

The ground floor contains three main tenancy/room entries. The eastern most tenancy features a large timber framed glass shopfront with a recessed central entry and a twin light French door. The design of the shopfront appears original to the building and sits on a raised stone sill. The timber framed glazing may be a replacement. Refer Figure 35.

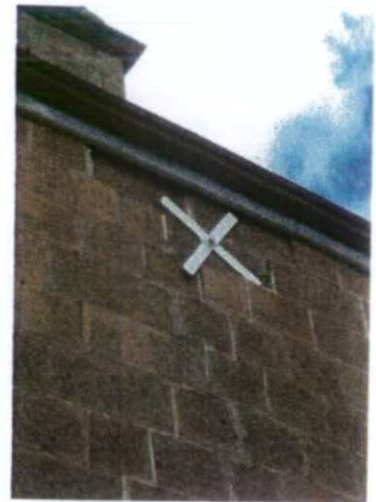
Figure 39

The west elevation exhibits significant bowing of the wall at the upper level with a series of cracks within the stone block joints and protrusion of the stone block coursing in relation to the cross plates of the tie rods. This has been identified by the structural engineer's earlier inspections as one of the two most significant structural issues related to the condition of the building.¹⁰ Refer Figure 39.

The condition of the western stone wall is generally poor, with inappropriate remedial cement pointing, spalling of the lower courses of stonework, and significant bowing and structural stability issues in the wall. These issues appear attributable to potential rising damp and foundation movement, both of which have a detrimental impact upon the long term condition of the stone blocks and the future stability of the wall. External site factors such as the adjoining road level and potential vibration received from traffic using the roadway, may also exacerbate the poor condition of the walls.

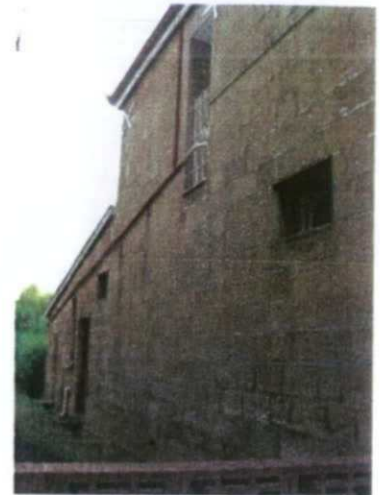
Figure 41

The two-storey component of this stone wall appears in better condition than the western wall. There is evidence of re-pointing, particularly in the lower block courses however the wall in general appears to be in a more sound condition with less weathered or exposed damage to the stonework than the western wall however the structural report noted an increase in the bow of the wall between October 2005 & June 2007.¹¹ Refer Figure 41.

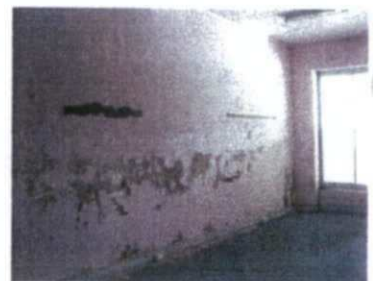
The perimeter stone walls are plastered and painted internally and exhibit significant areas of peeling paint due to rising damp in the walls. The level of the peeling paint sits approximately one metre above the floor level. The internal plastered masonry walls (separating the tenancies) exhibit a similar extent of damage. Refer Figure 42 & 43.

This condition of peeling paint and damp was a consistent height and was noted in each of the masonry and stone walls of the building.

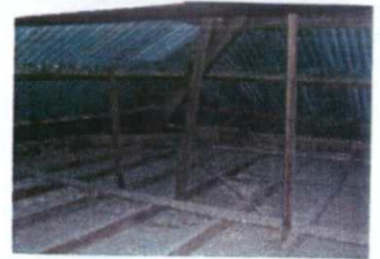
A second flight of timber stairs provides access into the roof space of the building. The roof structure appears to retain most if not all of its original roof framing members including ceiling joists and appears in a relatively sound and dry condition. The extent of bird droppings indicates that bird /vermin barriers are either missing or have failed. The roof sheeting

appears relatively sound, with no significant evidence of serious water ingress through rusted or degraded sheets. Refer Figure 47

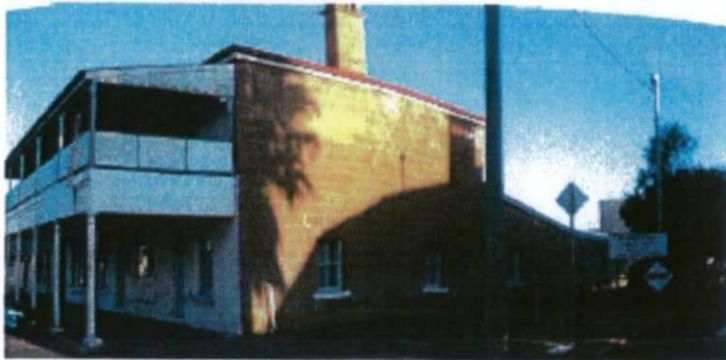
Photo 1.3 West Side View Oct 2005

The external walls have a number of tie rods connected to a cross of fist steel. One such can be seen in Photo 1.3. These generally occur at or adjacent to significant cracking in the external walls.

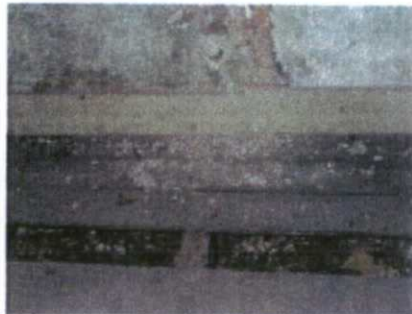
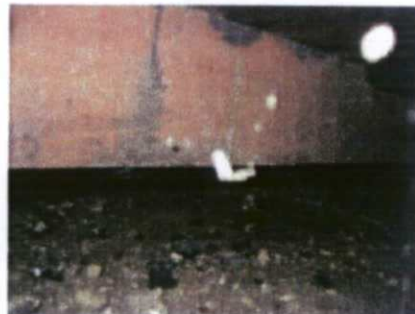
- 1.2 The ground floor framing is either on or in very close contact with the ground. (Photo 1.4,1.5) . This has led to deterioration of the floor structure and flooring itself through either rot or termite activity.

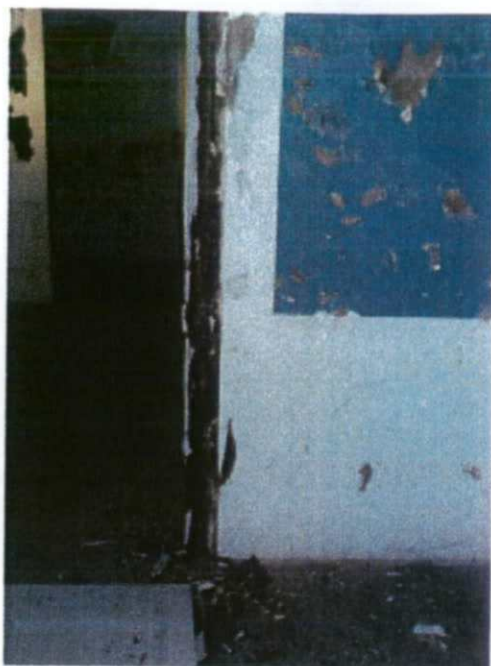
Photo 1.6 Termite Activity

- 1.3 It was not able to determine the nature and condition of intermediate supports for the ground floor system between the loadbearing walls. The recent inspection shows further termite infestation which is moving into the interior door architraves. (Photo 1.6)

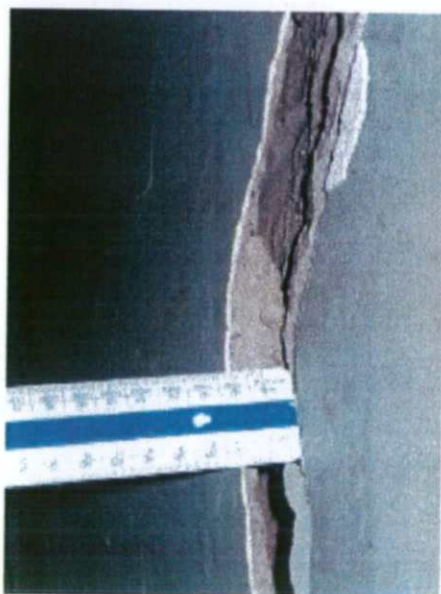
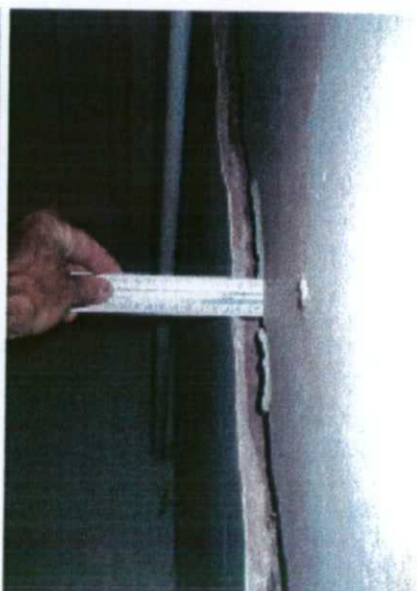
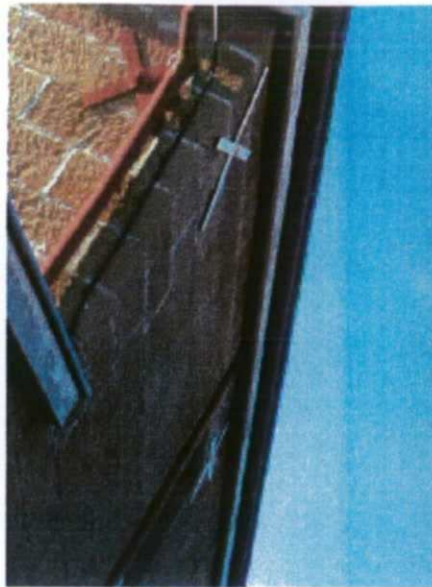
- 1.4 The external and internal walls exhibit extensive cracking with relative movements both translational and lateral. These cracks appear to coincide with cracking in external walls braced by tie rods referred to in section 1.1. There appears to have been further movement in the external walls between the earlier inspection and the more recent inspections. Photos 1.7 and 1.8 show an increase of approximately 5mm in the width of the same crack in the western wall in the intervening period, and similar photos 1.9 and 1.10 are photos taken almost 2 years apart.

Photo 1.7 Oct 2005 15mm

Photo 1.8 June 2007 20mm

There appeared to be an increase in the bow of the eastern wall on the at the location of the centre tie rod between the time of the two inspections.

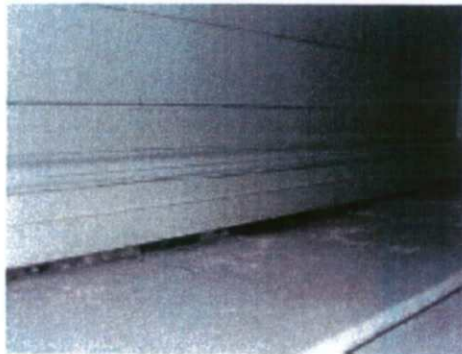
Gaps between floor and western wall
 Photo 1.11 June 2007

- 1.5 Access was not available to view the upper floor framing. Isolated termite damage was evident in skirtings and mouldings. A closer inspection of the upper floor framing involving removal of the ground floor ceilings would be necessary to ensure the stability and competency of the supporting members. However, the gaps between the floor and the walls are significant. Photos 1.11 1.12. Concern exists as to the support of the floor framing if this movement continues.

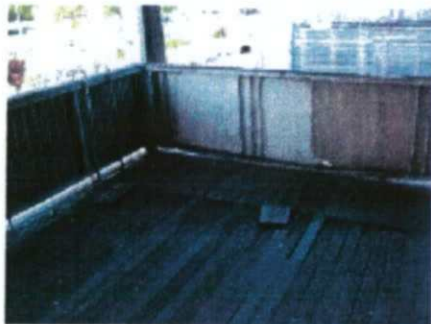
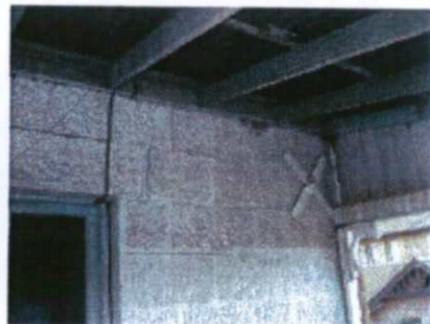
The upper floor front verandah is in a deteriorated state, with rotten boarding and joists. The balcony rails are in poor condition. The roof framing comprising rafters spanning from the stone walls to timber bearers in reasonable condition, but the walling shows signs of movement (Photo 1.15 1.16). There is further deterioration in the condition of the balcony.

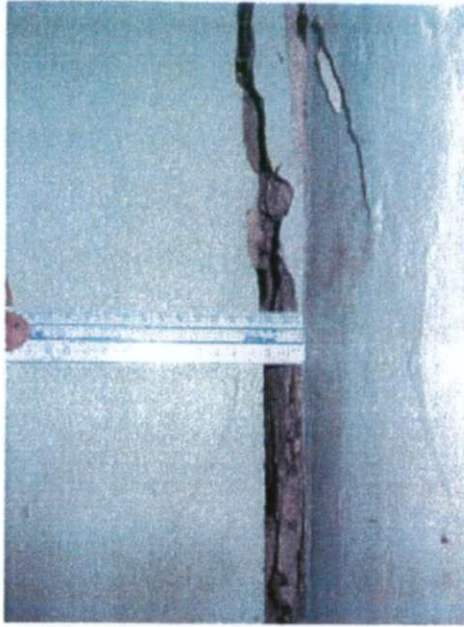
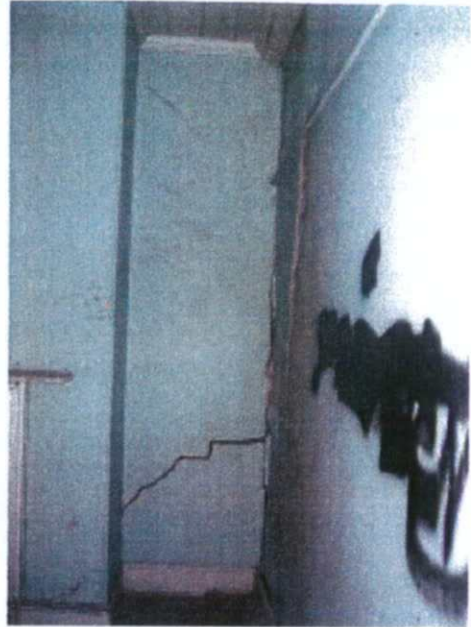
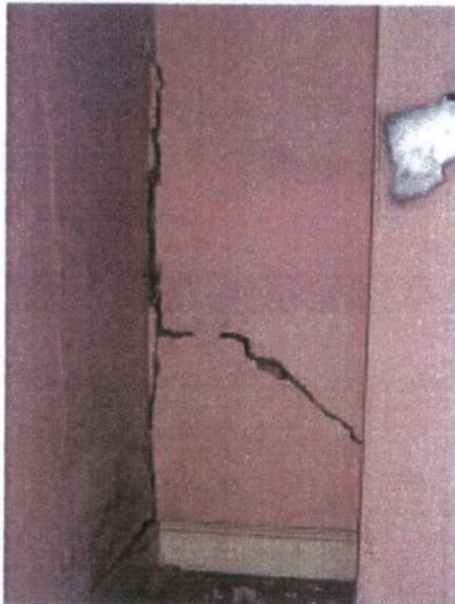
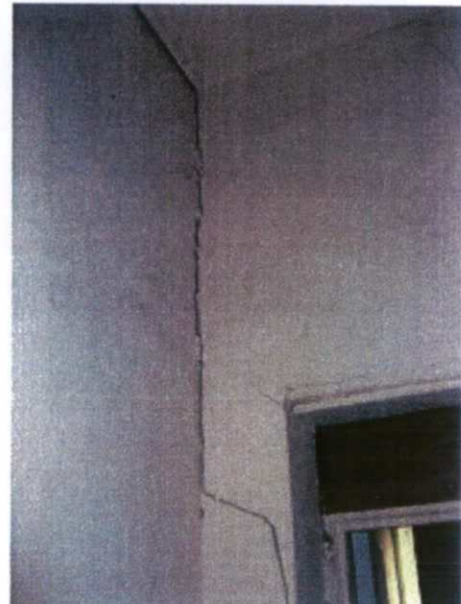
All internal walls are cracked where they adjoin external walls, with crack widths of 15-25mm in width occur in a number of instances, and cracking over windows and doors is extensive.. (Photos 1.17 -1.20)

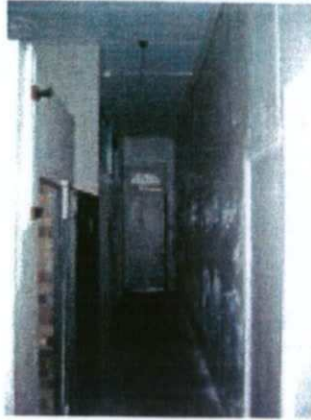
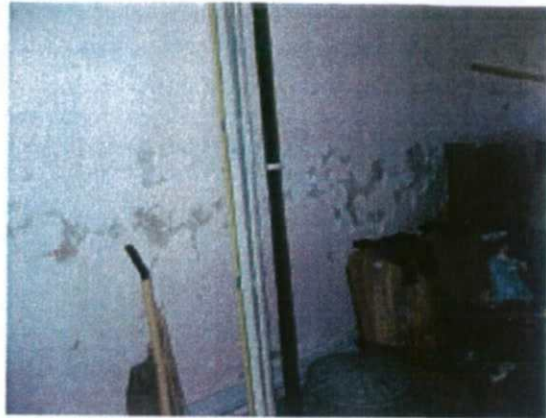
- 1.7 Rising damp affects the majority of the lower floor walls. Photo 1.21 1.22

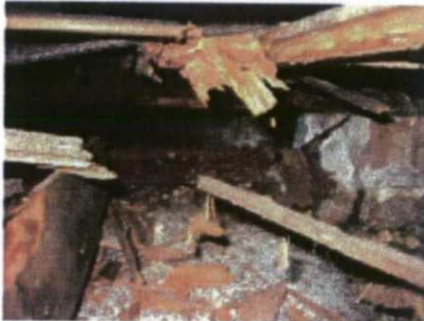
Photo 2.3 Oct 2005

- 2.2 The lower floor is very unstable with extensive areas of collapsing floor framing, rotten floor boards and joists, leaving movement on the floor dangerous. Photos 2.3, 2.4 show examples.

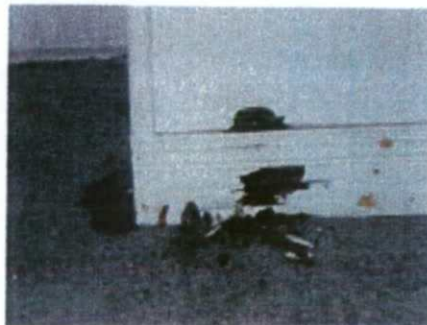
Photo 2.5 Oct 2005

- 2.3 Evidence abounds of termite and rot damage in walls skirtings and mouldings. Photos 2.5 2.6

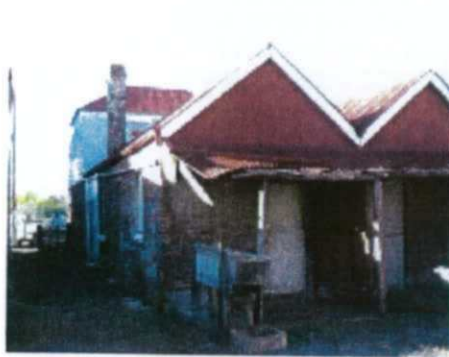
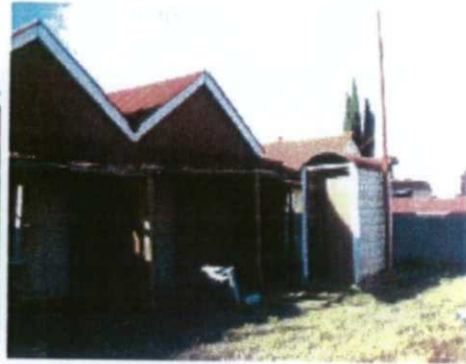
2.4 The rear verandah framing is on the verge of collapse Photo 2.7, 2.8.

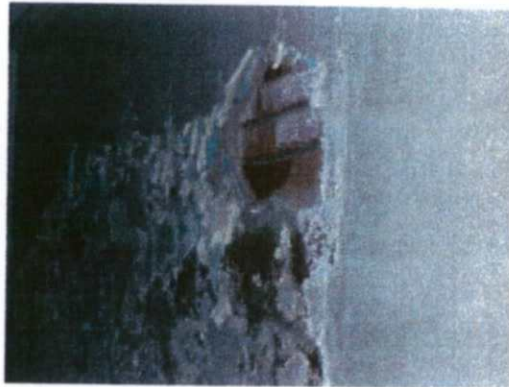
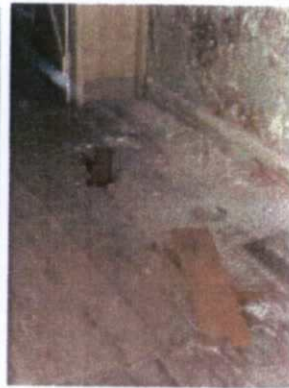
2.6 Walls show significant damage from rising damp. Photos 2.9-2.10.
