CONSERVATION ASSESSMENT REPORT

**PLUMB'S CHAMBERS
82 & 84 FITZROY ST
WARWICK**

**For
The McConaghy Group**

**Prepared by Watson Architects
July 2008**

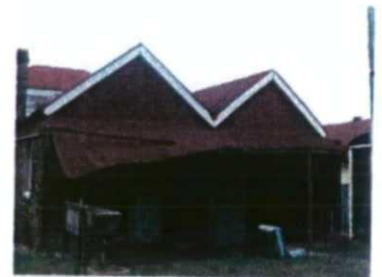
Figure 4

The street front masonry wall is rendered and painted and includes a painted sign for Plumb's Chambers. The eastern perimeter brick wall is painted while the western masonry wall has remained unpainted. Each side wall contains two single doors and two timber-framed double hung windows along their length. The windows on the western wall feature painted sandstone sills and sandstone lintel blocks. The eastern wall features a mix of sandstone sills and lintel blocks and brick arch lintels. The rear of the building contains an access door from each tenancy onto a small concreted area covered with the corrugated iron lean-to roof. Refer Figure 4.

The rear awning is in a state of collapse. Refer Figure 4.

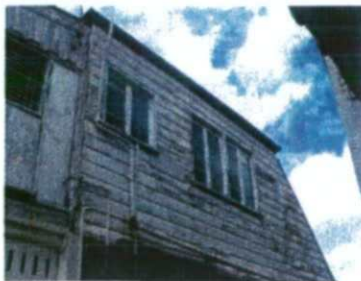
Figure 12

The painted timber chamferboards to the upper level appear generally in poor condition. The western elevation includes peeling paint and areas of missing boards with rotting and decaying boards at the floor level. Termite damage is also visible at the floor level. Refer Figure 12. The south and east elevations appear in similar condition with a rusted metal patch in some sections and missing boards in others. Refer Figure 13.

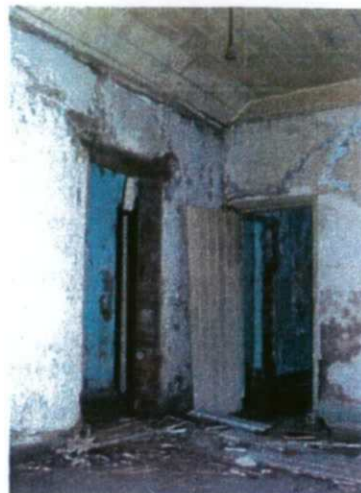
Figure 19

The masonry walls all show substantial evidence of rising damp, with peeling paint, efflorescence and degrading plaster. The internal masonry wall separating the two shops exhibits significant water damage and cracking with failure of rotten timber lintels at openings. Refer figures 19 & 20. Significant cracks are also visible within the wall and the plaster, particularly in the rear section of the building.

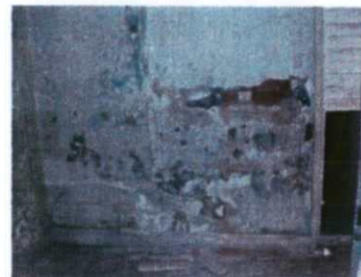
Figure 21

Generally the rear section of the building appears substantially damaged due to water ingress, rising damp, termite attack and possible settlement within the walls. Refer Figures 21 & 22. The front section of the building exhibits significant termite damage, rising damp to the masonry walls and a rotted, failed floor structure. Refer Figure 23 & 24.

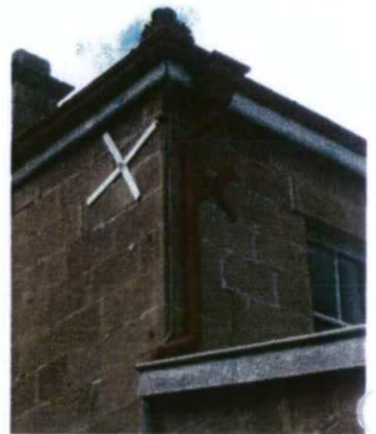
Figure 28

The upper level stonework of the elevation appeared relatively sound with some joints appearing to have been re-pointed. Cracking at the south-west window head is visible. Refer Figure 28.

The main hip roof features short sheeted galvanised iron corrugated iron roof sheets with a red oxide finish. Their condition appears relatively sound. Metal acroteria remain on the southern corners of the roof and the short-length ridge flashings are scribed. Rainwater goods include ogee gutters and metal rainwater hoods and downpipes finished in red oxide colour. Refer Figure 28.

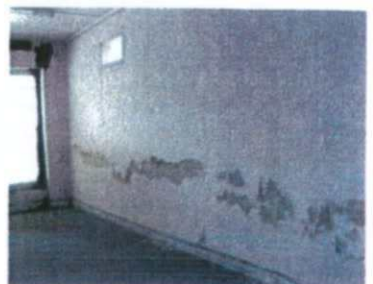
Figure 43

The perimeter stone walls are plastered and painted internally and exhibit significant areas of peeling paint due to rising damp in the walls. The level of the peeling paint sits approximately one metre above the floor level. The internal plastered masonry walls (separating the tenancies) exhibit a similar extent of damage. Refer Figure 42 & 43.

The original shop tenancies also feature a central stop-chamfered timber column and headstock supporting a main bearer. An internal circular steel column flanks each side of the recessed entry to help support the span of the shopfront opening. Significant termite activity is evident in the north-eastern corner of the shopfront with tunnels and nest leading up to the ceiling. Refer Figure 43.

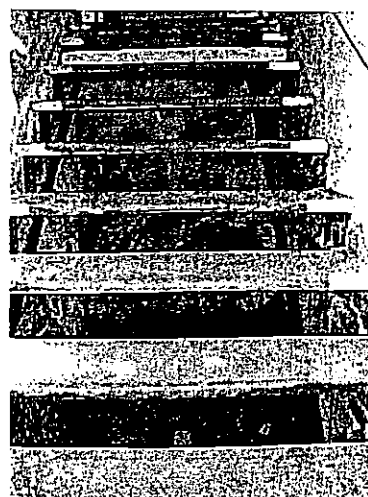
Figure 44

former central tenancy. The flight is built against the wall of the strongroom and has open treads and steel stringers. The subfloor space is visible under the stairs, indicating a shallow clearance between the ground surface and the floor framing. Refer Figure 44.

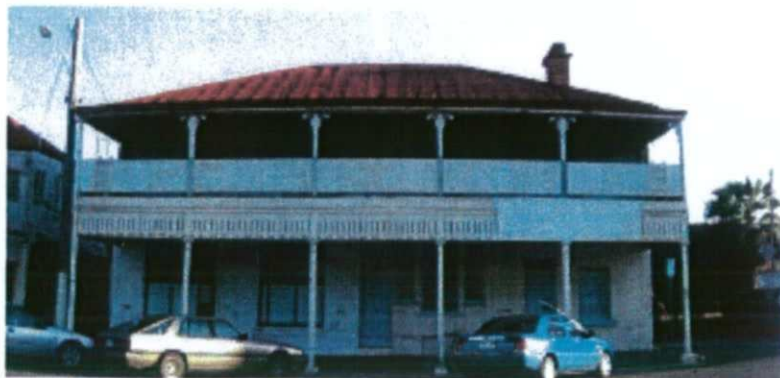
Photo 1.1 Front View Oct 2005

- 1.1 The building is a 2 storey structure constructed from loadbearing sandstone masonry, possibly brickwork internal masonry, with timber floor and framing approximately 100 years old. More recent additions exist to the rear of the site, comprising single storey timber framed additions. Photo 1.1 1.2 1.3.

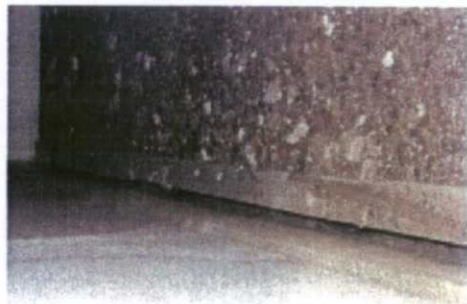
Photo 1.12 June 2007

- 1.5 Access was not available to view the upper floor framing. Isolated termite damage was evident in skirtings and mouldings. A closer inspection of the upper floor framing involving removal of the ground floor ceilings would be necessary to ensure the stability and competency of the supporting members. However, the gaps between the floor and the walls are significant. Photos 1.11 1.12. Concern exists as to the support of the floor framing if this movement continues.

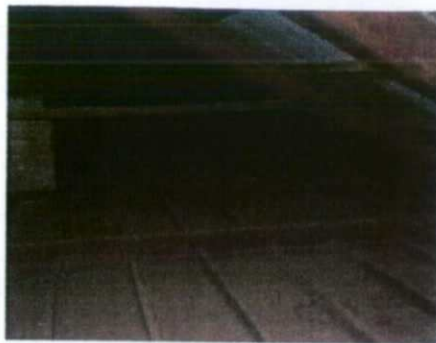
Photo 1.13 Oct 2005

- 1.6 Access was gained to the roof space. The roof framing is timber battens, rafters, underpurlins and ceiling framing. Photo 1.13 1:14. There did not appear to be any significant change in the condition of the roof framing.

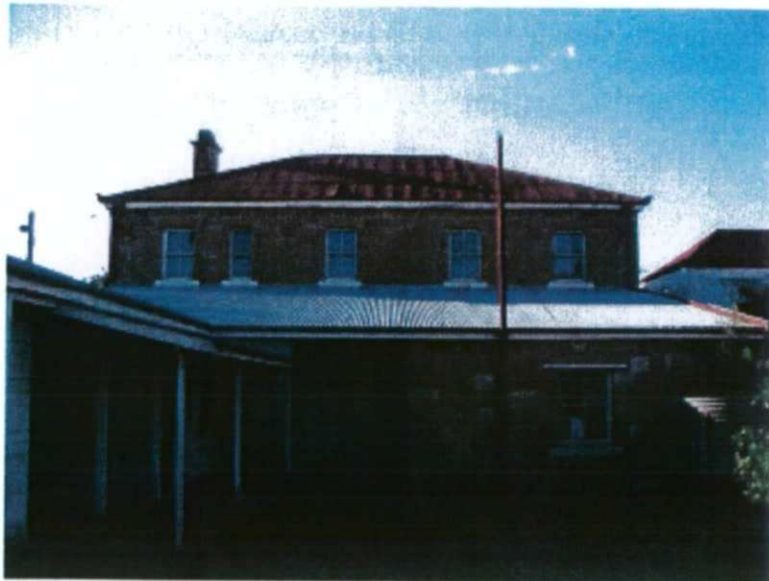
- 1.8 The newer rear addition is of timber framing on a slab-on-ground. The condition of this structure is reasonable.

Photo 1.3 Rear Newer Building from rear yard June 2007

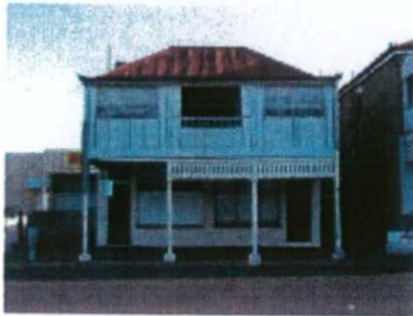
Photo 2.1 Oct 2005

- 2.1 The eastern building is a brick masonry and timber framed structure on indeterminate age. The lower floor wall framing is masonry, with the upper floor of predominately timber framing. (Photos 2.1 2.2) Access could not be gained to the lower floor in June 2007 to assess the current condition.
